Stranding of cruiser Dragonfly at Thorpe Bay, 15th May 2013

Introduction

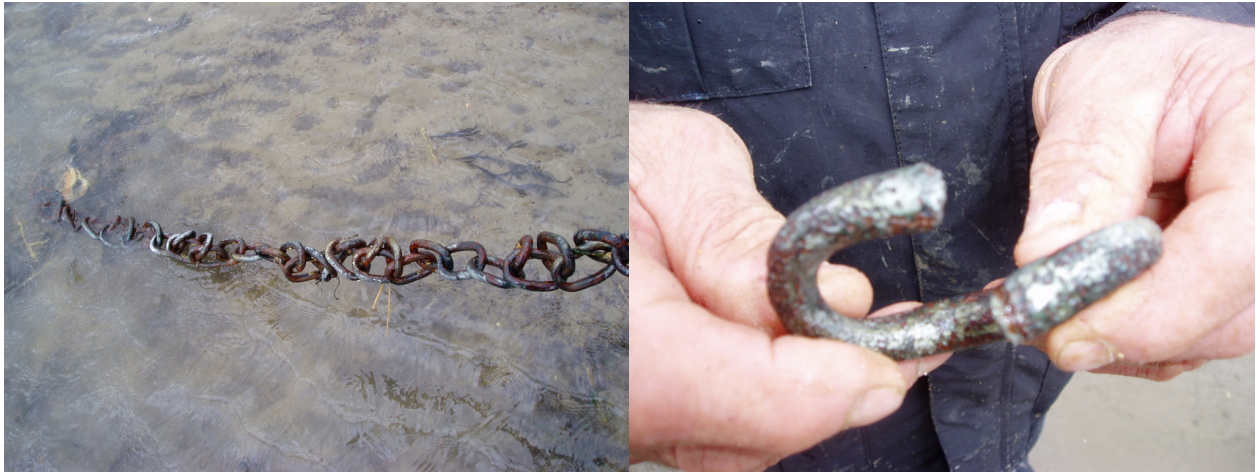
Dragonfly's mooring failed due to a link twisting about 45°, separating at the weld. It is my understanding that the chain was 12mm tested chain, bought in 2010 and installed under Mooring Officer's supervision on the root dig that year, fully meeting TBYC recommendations. The chain had some wear and rust but appears good for several years more.

The riser chain attached to the root. The riser was even more twisted when first seen.

With the twisting on this link, the link must have broken and continued to twist under tension before the chain separated. (In the chain photo it looks as if another link might be starting to twist - need to check the chain again.)

1. Our current mooring guide is lukewarm on swivels, as they themselves are a single point of failure. We should revise this to say that if twisting of the chain is seen, a good quality swivel SHOULD be fitted. (Large buoys (where the pull is taken through the buoy by design) have a swivel built in.)
2. We should keep an eye on forecasts and recommend mooring checks before & after onshore storms.
3. We should make sure the TBYC Secretary has Beach Hut Association contact details.
4. We should recommend that moored yachts with fixed rudders immobilise them in a fore & aft position, and that boats with removable rudders have a drogue fitted if they tend to sail round their mooring.
5. We should continue to recommend comprehensive boat insurance rather than 3rd party only.
6. We should promulgate our conclusions to members.
